From: [REDACTED]
Sent: 10 November 2023 12:28
To: DDC Housing <housing@dover.gov.uk>; [REDACTED]@DOVER.GOV.UK>; [REDACTED]
[REDACTED]@DOVER.GOV.UK>; [REDACTED]@DOVER.GOV.UK>; DDC asset.management
<asset.management@dover.gov.uk>
Cc: [REDACTED]@DOVER.GOV.UK>; [REDACTED]@dover.gov.uk>
Subject: RE: Flooding at Durban Crescent.

REF: Street Record Durban Crescent Dover CT16 2JJ.

Project Name	Project Number	Project Date
Durban Crescent Dover CT16 2JJ		12/02/2024

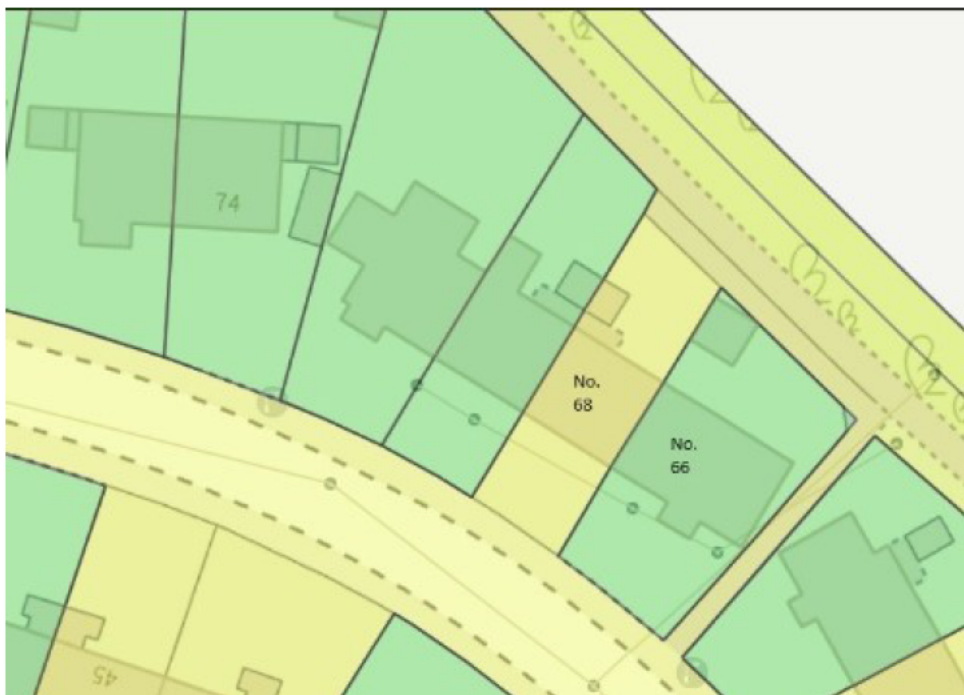
- The ditch line behind the property is not a designated watercourse as there is no onward flow, therefore it sits outside of legislation and is what is known as a 'linear pond'
- the ditch line appears to have been created to catch run off from the field and at one point was a considerable sized channel
- the channel is now limited to only one section of about 4m that can effectively hold water and multiple instances of fly tipping into the channel was observed during our time on site
- The volume of water running off the field is now exceeding channel capacity due to the level of silt, detritus and vegetation growth within the channel
- from the map information provided it looks as though this ditch would be considered part of the DDC owned land and would therefore require maintenance to be undertaken by DDC rather than the adjacent landowner

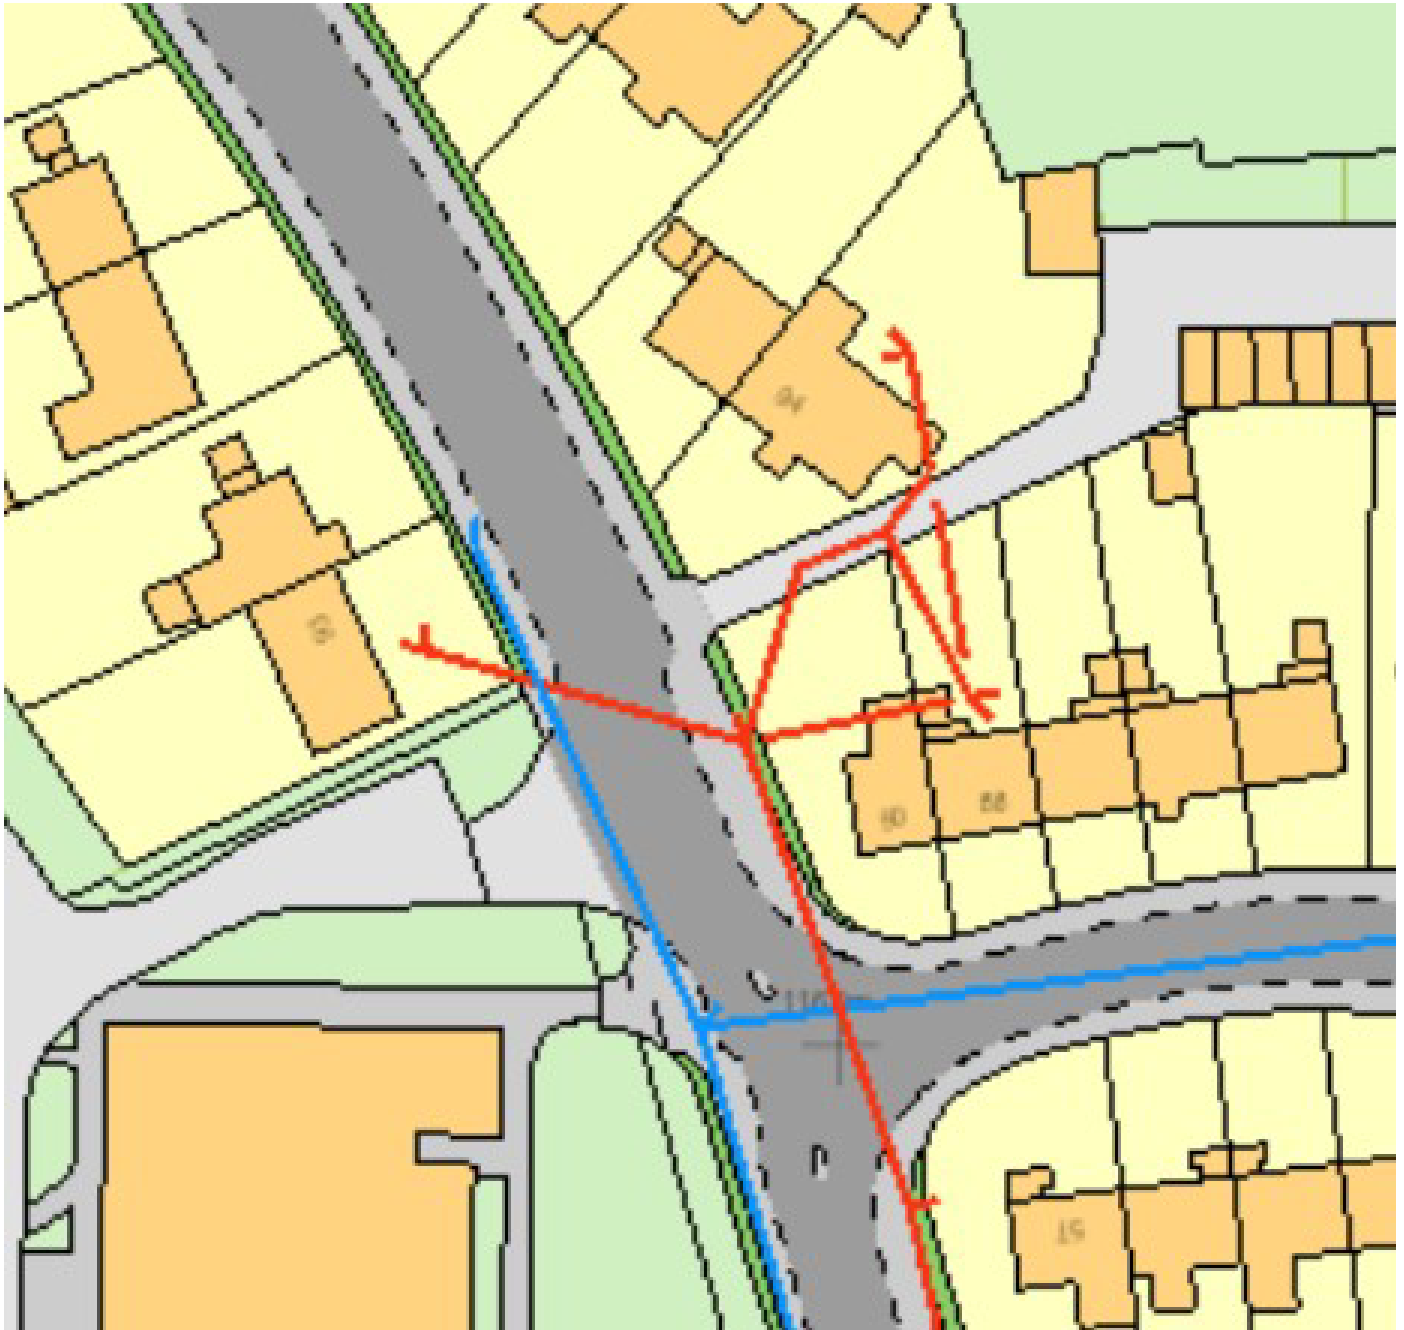
- The maps show a small section of adopted foul line outside the property (red line) and also a surface water line (blue line) that ends in the ditch, as the channel doesn't flow on, I assume that it discharges to soakaway however we could not find a cover on site due to vegetation growth. A metal detector may be required to locate the cover.

- The waterboard should check their system for blockages and also need to confirm the outfall at the end of the ally - if there is a soakaway to the rear, this should be cleared with the cover exposed and at the very least an inspection of the condition of the soakaway as it may need to be cleared of silt
- Sewage and surface water do not normally mix and are kept separate unless in a marked combined system, as the property was experiencing issues with the washing machine and toilet etc this would indicate as issue with the sewer, as the red line is disconnected from the rest of the system it may be that pipework between this point and the main line are private and may require action from a

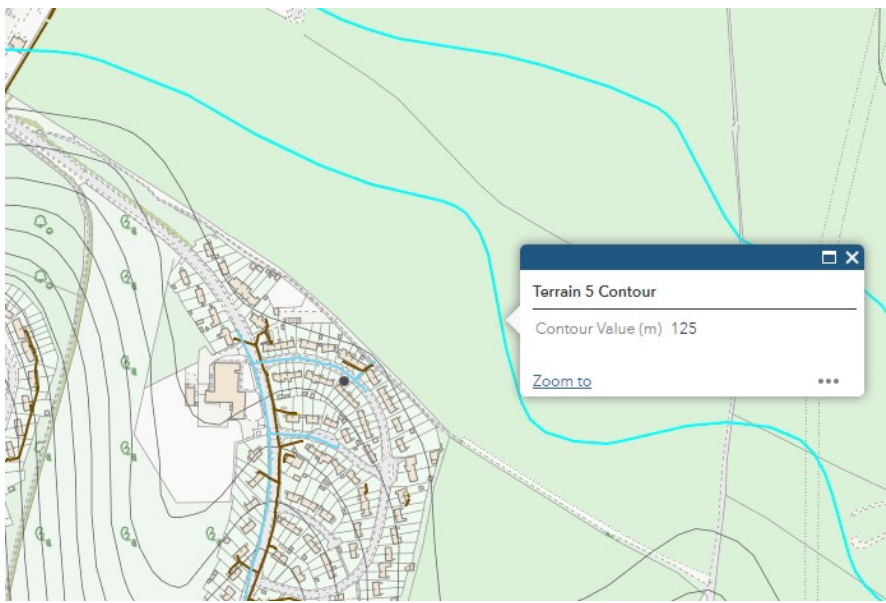
If the surface water system was surcharged at the time of flooding I would be expecting surcharging of MH`s down stream and reports of this being made but as yet none have. If you are having water not getting away from a ditch which I do not believe should be connected to our asset in the first instance then this sounds like a flow rate issue into the drainage ditch. If this is coming off the farmland adjacent is this not an issue for the owner of that land to control surface water? A single storm drain in a 100mm sewer is not that big and most likely not suitable for what it is being asked to take.

Looking at gradient of the farm land everything south of the lower blue line is coming towards the properties.

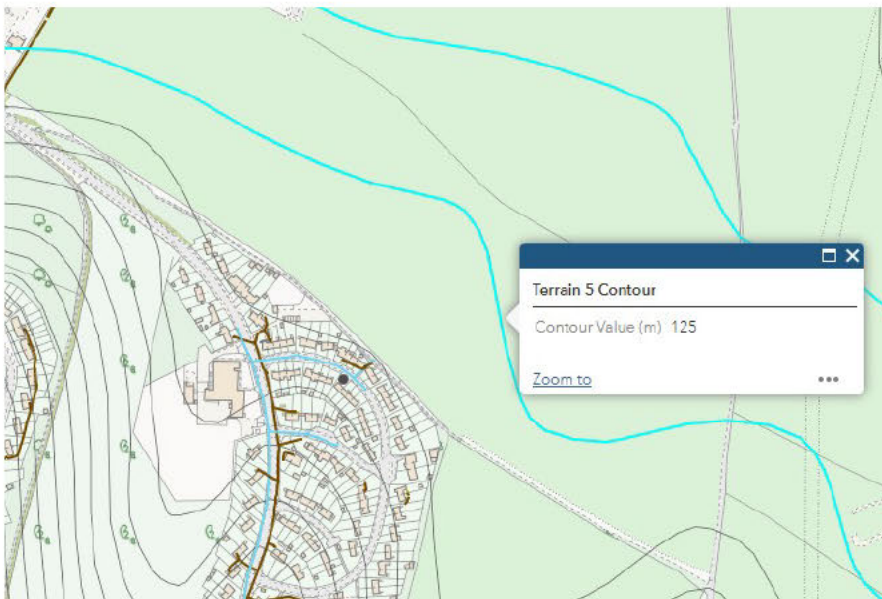
If the surface water system was surcharged at the time of flooding I would be expecting surcharging of MH's down stream and reports of this being made but as yet none have. If you are having water not getting away from a ditch which I do not believe should be connected to our asset in the first instance then this sounds like a flow rate issue into the drainage ditch. If this is coming off the farmland adjacent is this not an issue for the owner of that land to control surface water? A single storm drain in a 100mm sewer is not that big and most likely not suitable for what it is being asked to take.

Looking at gradient of the farm land everything south of the lower blue line is coming towards the properties.

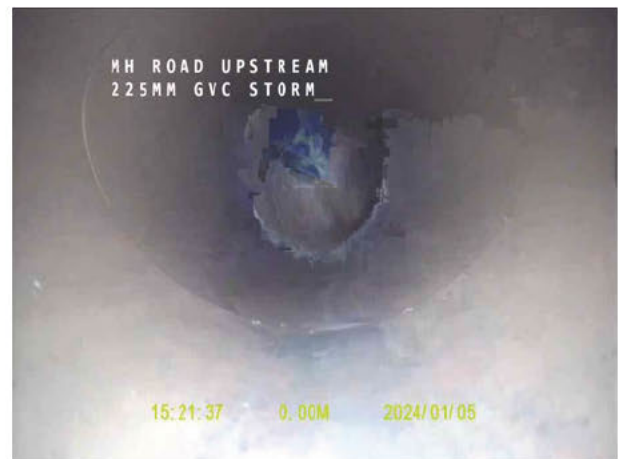
4, 00:00:28, 8.00 m
Crack, circumferential from 12 o'clock to 12 o'clock

Repair required, install a 225mm x 550mm local liner to seal the crack £912.01+vat.

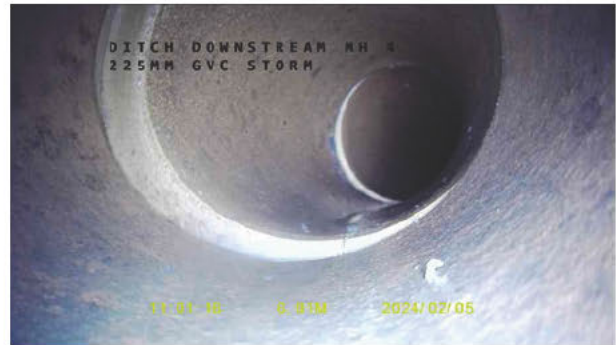
4, 00:02:03, 7.00 m
Line deviates right, 15 degrees

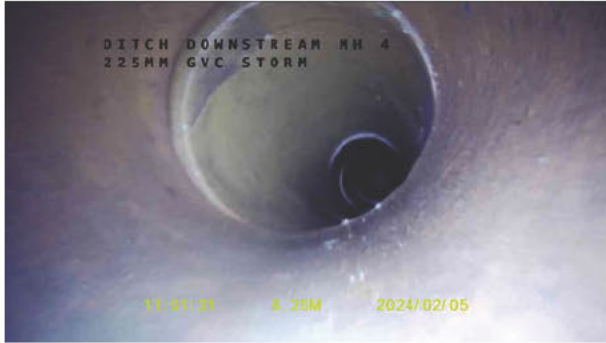
5, 00:02:19, 8.30 m
Crack, circumferential at joint from 9 o'clock to 1 o'clock
